Manufacturing of PIP-II high power couplers - Experience feedback

S. Kazakov / FNAL

PIP-II Technical Workshop

December 2, 2020

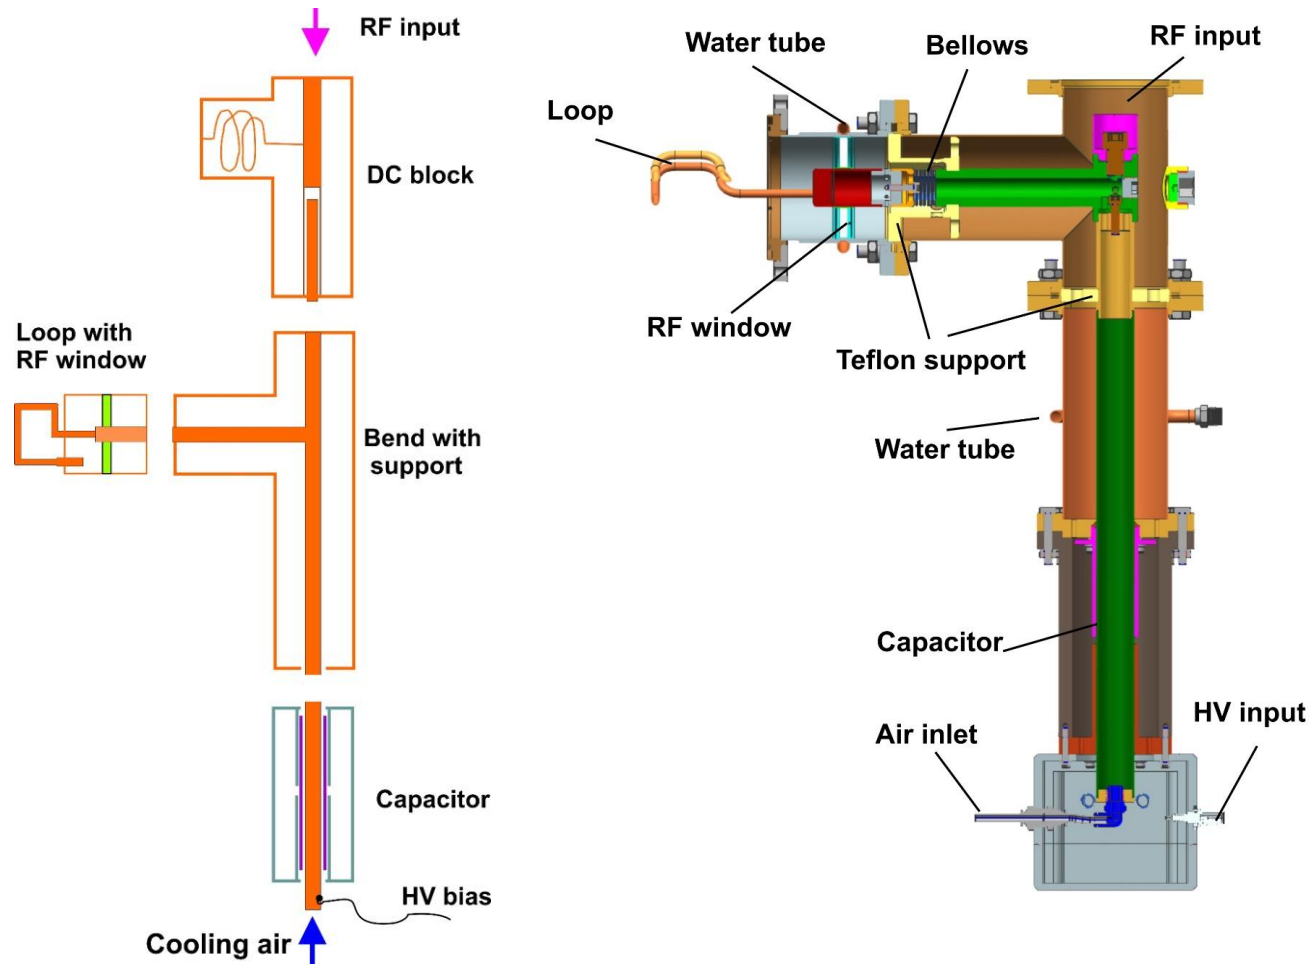
RFQ, first design.

RF window: 3-inch ceramics. Air cooling of inner conductor and water cooling if outer conductor.

Two couplers and 4 RF windows produced by "Mega Inc." Mega is very good company for producing air filling waveguide systems. But Mega had no previous experience to braze RF windows. Finally they produced 4 windows with antenna with big delay. One window had a small leak but was accepted and installed to RFQ because of big delay.

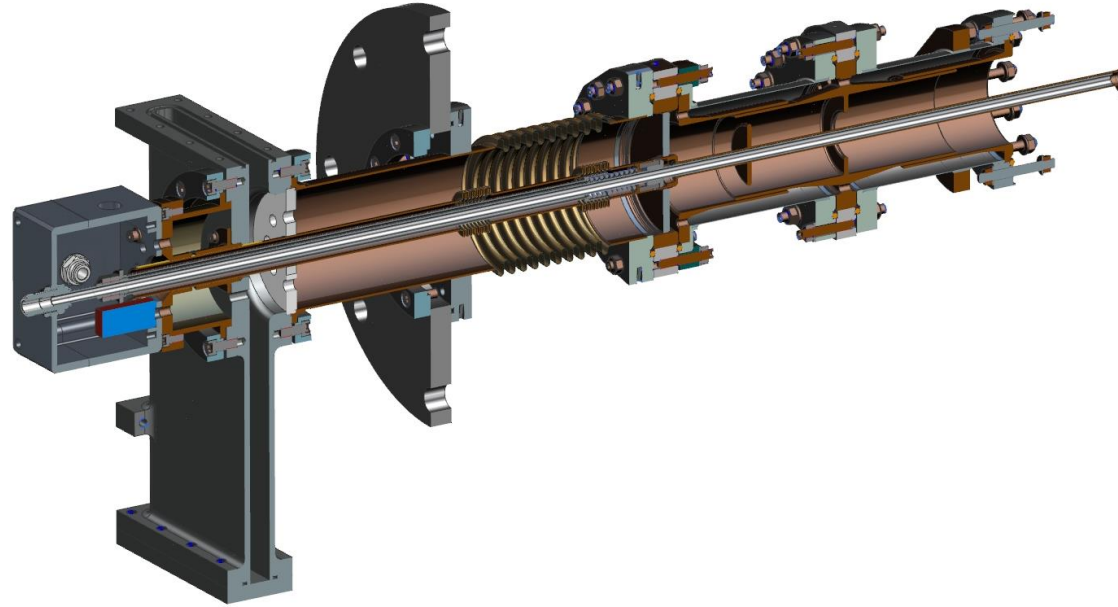
650 MHz coupler.

650 MHz coupler were designed considering all experience we got from 325 MHz couplers. Window configuration was changed to make brazing simpler. Couplers we placed for production into CPI from the beginning. Ceramic disks were checked before production. Windows were not coated with TiN. As results, Coupler were produced in time but with small incident: during incoming inspection windows were checked for vacuum tightness in vertical position. All windows were vacuum tight. But in operation horizontal position a small leak appeared at one window. Leak was cured with Vacseal. Window was successfully used for room temperature tests but could not be used for cold tests with SC cavities.
